# **Coal Mine Bumps: Five Case Studies in the Eastern United States**

By Alan A. Campoli, Carla A. Kertis, and Claude A. Goode

**Information Circular 9149**

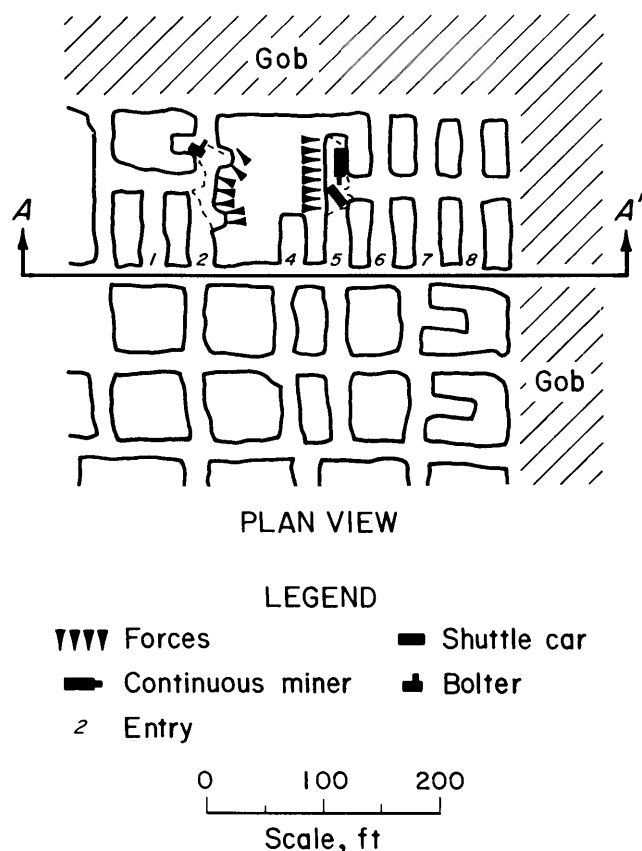
Figure 10.—Plan view of area of bump accident on October 18, 1983, mine 1.

On October 18, 1983, two miners were killed by a bump accident on a continuous miner section, located as marked on figures 7 through 9. No deviations from the general structural trend were evident in the area (fig. 7). Therefore, unusual structural conditions did not lead to the occurrence of the bump. Overburden thickness was in excess of 900 ft (fig. 9). Additionally, data from a Mine Safety and Health Administration (MSHA) accident report (5) and in-mine observations indicated that a hard sandstone approximately 60 ft thick was present immediately above the coalbed (fig. 7). The bump occurred during the mining of the 140- by 350-ft No. 3 barrier pillar. Figure 10 illustrates the conditions directly after the accident. Eight entries on 39-ft centers were planned to divide the pillar. Forces from the bump moved the continuous miner against the right rib and the shuttle car into the crosscut between entries 5 and 6 (fig. 10). The left rib in the No. 5 entry was displaced approximately 8 ft and coal filled the rest of the entry to a depth of 42 in for a distance of approximately 86 ft. The displaced coal is indicated by a dashed line on figure 10. The roof bolting machine was not moved by the forces; however, coal was expelled, filling the No. 2 entry with coal from 3.5 to 5 ft deep, for a distance of 60 ft (5).

specific approach to mining was determined on block-by-block evaluation, based on the knowledge of the miners and mine management (5). Two pillars of similar size and shape (directly inby) were mined prior to the fatal bump pillar (fig. 11). The No. 2 barrier pillar was also developed using the narrow-room method. It bumped during an idle shift, expelling several tons of coal and moving the continuous miner. The No. 1 barrier pillar was split into blocks similar in size to the adjacent chain pillars and was retreated without incident.

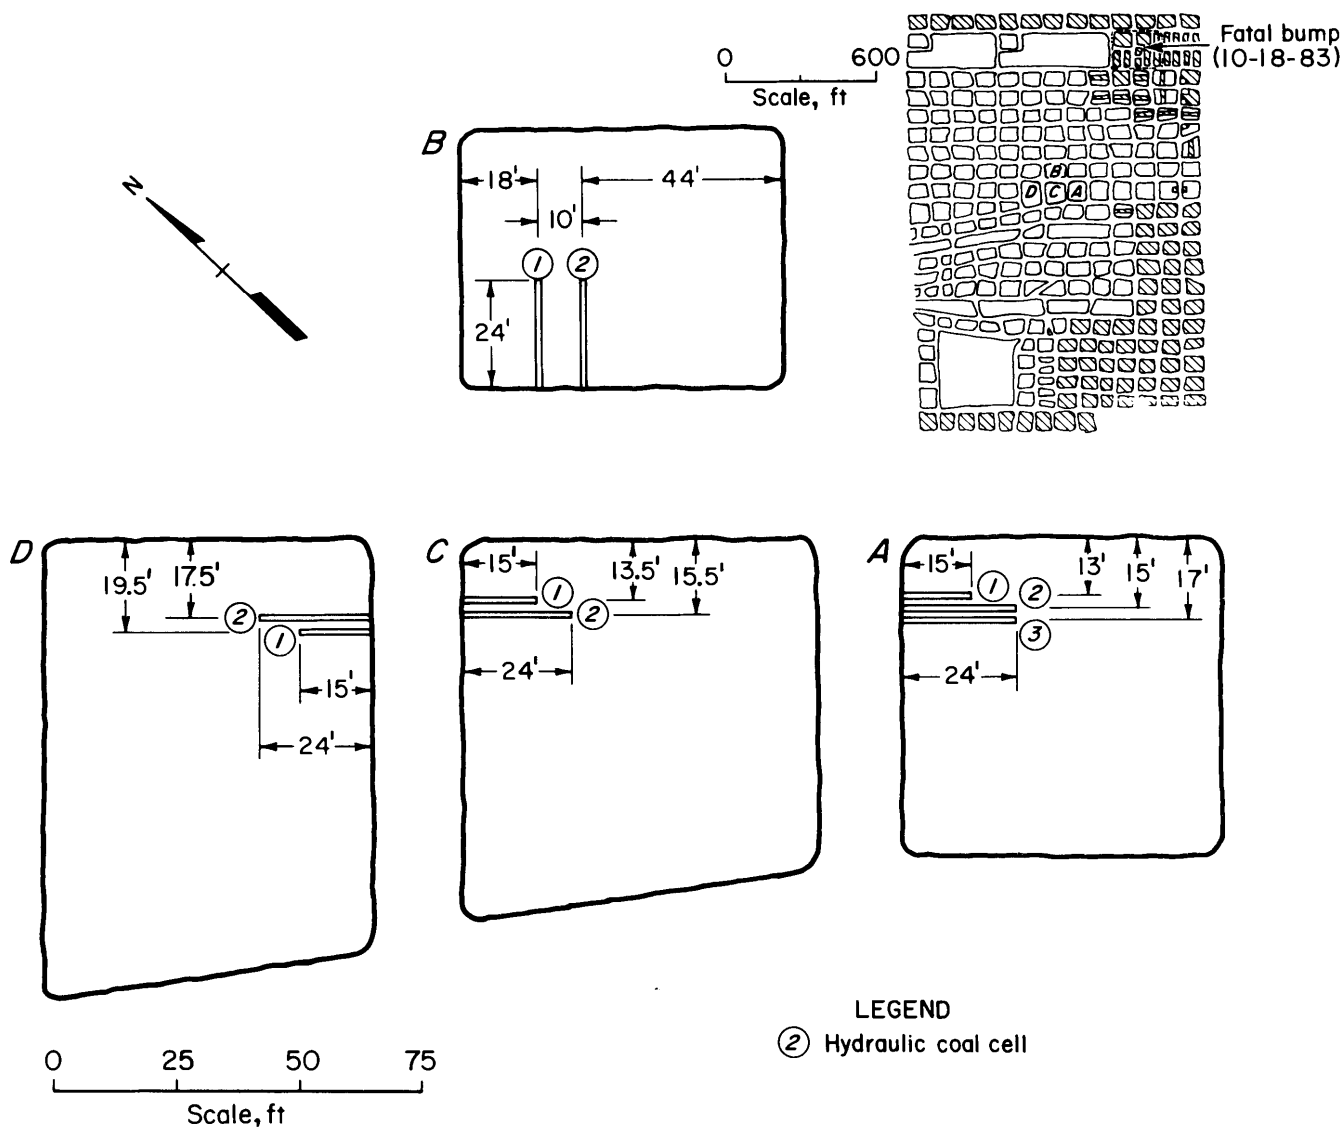
Figure 13.—Location of hydraulic load cells, in pillars A, B, C, and D, in relation to area of bump accident, mine 1.

While the cells were not placed uniformly with respect to the pillar geometry, they do demonstrate three trends. Pillars A and D did not load significantly until the nearby inby pillars were split (fig. 15). An increase in cell readings

did not take place in pillar D until mining period 5 (fig. 14). At that time pillar C was split halfway and bump cuts were made in a pillar adjacent to pillar A. Second, the cells load evenly up to the point of periphery yield and confined core loading. This phenomenon is verified by all cells except for the data from pillar B. Finally, all four pillars demonstrated an increase in core loadings upon periphery yield.

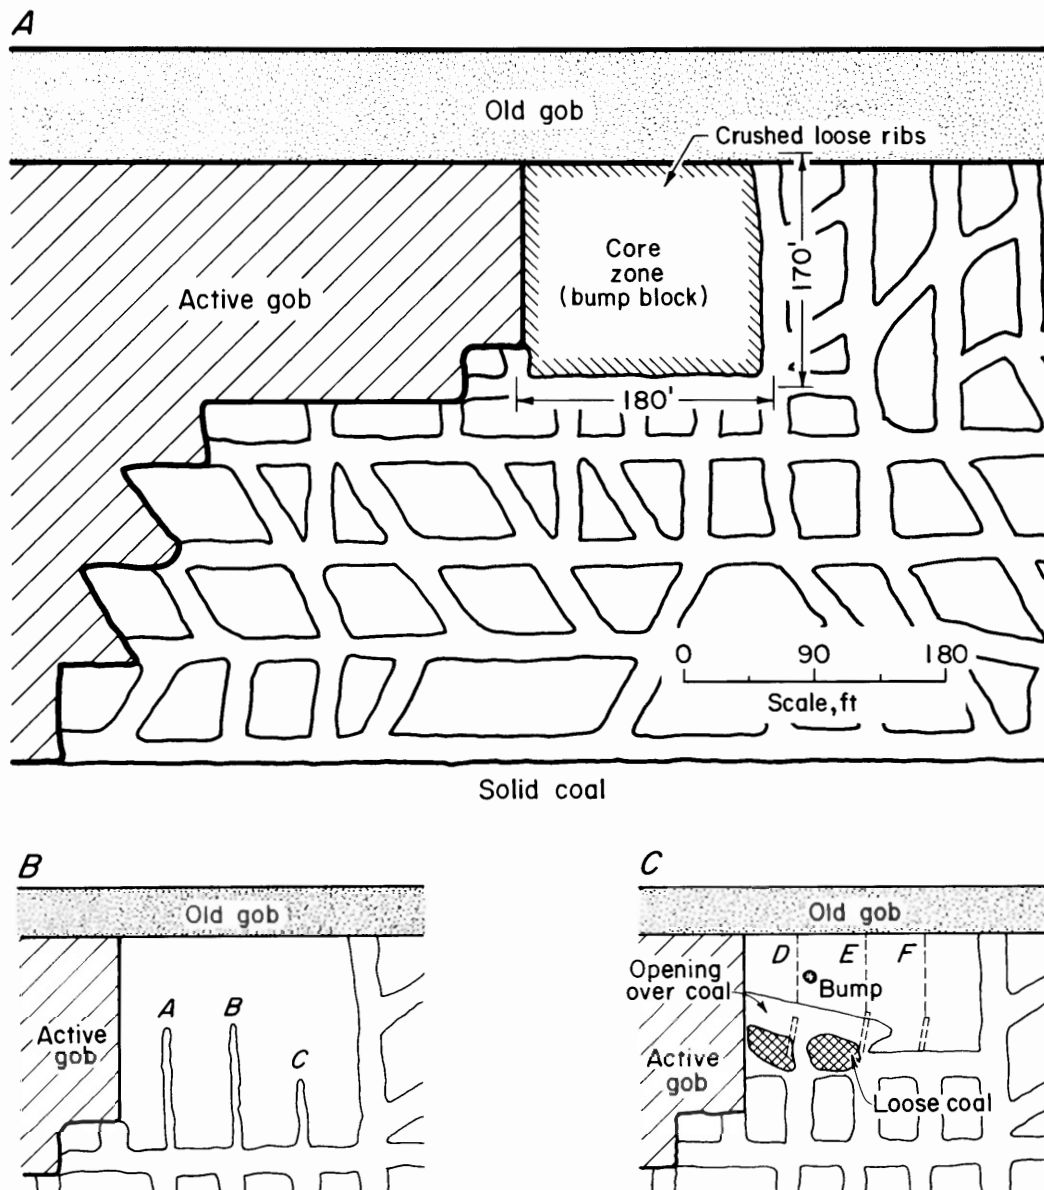
Figure 21.—Results of auger drilling of bump block left by thin-pillar mining method, mine 2.

Stress relief drilling experiments were conducted in mine 2 to determine if auger holes (24-in diameter) could be mined safely. Figure 21A displays a 180- by 170-ft bump block that was formed by the removal of a barrier pillar. The coalbed is 7 ft 4 in thick and the depth of cover is 1,100 ft. The bump block was destressed by auger drilling. Holes A, B, and C were drilled to their predetermined depth of 95 ft from behind barricades (fig. 21B). Upon completion of hole C, three entries following the auger holes were advanced 75 ft and connected by a crosscut. As the crosscuts were being driven, the last 35 ft of the holes closed. Prepara-

tions were made to drill holes D, E, and F, which were continuations of holes A, B, and C. Hole D (fig. 21C) was at a depth of 149 ft in the crushed coal area of what was formerly hole A, when a very heavy bump occurred. Approximately 1,000 st of coal was thrown into the entry. An area 100 by 35 ft was opened over the coal pillar by a gap of 8 to 12 in. Because of the extreme precautions taken, no serious injuries resulted. Drilling resumed and another bump was encountered in hole F, which totally destressed the block. The bump block was then retreated without further incident.

While the preceding example demonstrates that a bump block produced by the thin-pillar method can be destressed, auger drilling was discontinued shortly afterwards because it was considered by the operator to be uneconomical and dangerous. The thin-pillar method is still employed but the bump block is now left. These holding blocks, as they are called by mine personnel, serve to provide a rigid member that enhances the probability of breaking the main roof at the pillar line and to protect the remainder of the section from squeeze development.

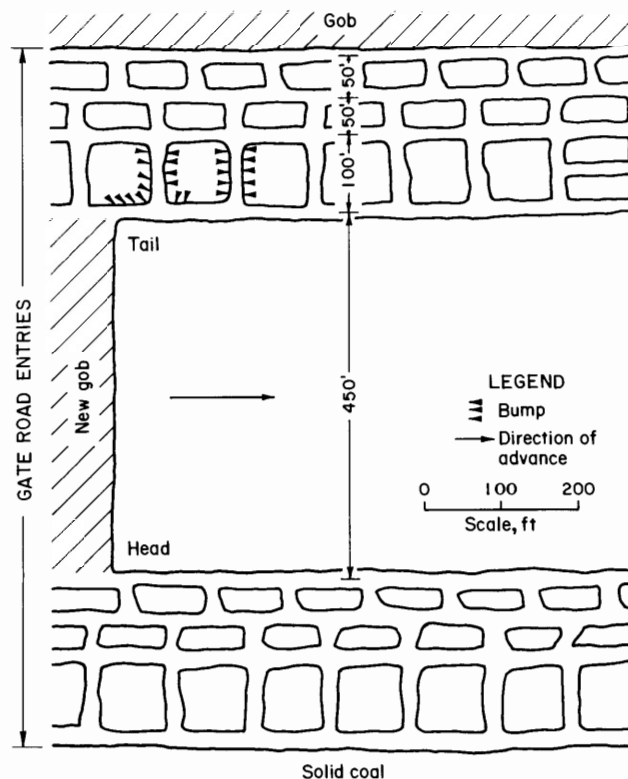
Figure 27.—Plan view of longwall gate road entries and location of bump event, mine 3.

Where strata underlying the Pocahontas No. 3 Coalbed in mine 3 are generally soft, the bottom heaves readily. However, in the area of the bump outlined in figure 27, the bottom was composed of a competent sandy shale, which was generally resistant to heaving. The combination of the load transferred to the tailgate from the adjacent gob area (formed by the previously removed panel), the abutment pressure in advance of the longwall plow face, and the unyielding bottom strata, in the operator's opinion, caused the bump. The 100- by 100-ft block was too large to yield under load. Thus, the pillar stored energy until explosive failure occurred.

Two steps were taken by mine management to prevent further bump hazards: (1) the softening, via shot firing of the large tail entry pillar, and (2) a redesign of the gate roads for subsequent panels. Where firm, unyielding roof and floor strata are present with over 2,200 ft of overburden

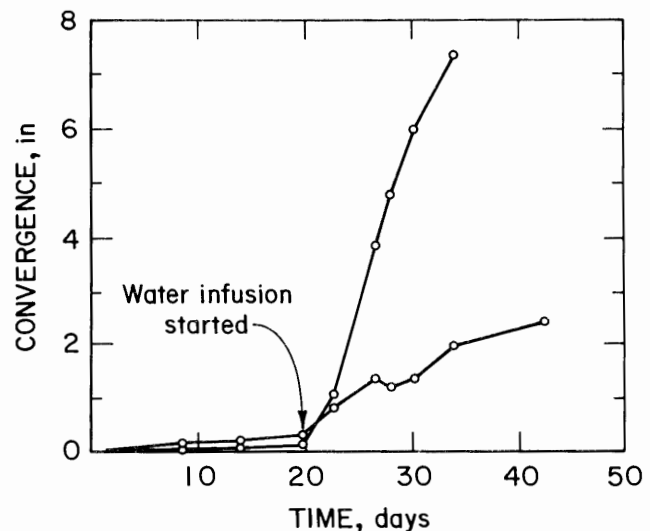
Figure 31.—Graph of convergence effects of water infusion of pillar C (fig. 30), mine 3.

The water infusion of pillar C was accomplished by pumping water at 800- to 1,200-psi pressure, into the pillar at a rate of 10 gal/min. Figure 31 shows the effect on the convergence rate around the infused pillar. The dramatic increase in the convergence rate caused by the water infusion led mine officials to assume that the pillar was distressed. It was then mined without incident. The same test was performed on other pillars. The increases in convergence rate were not as pronounced, but the pillars were mined without incident. Water infusion is not presently conducted for bump control at mine 3.

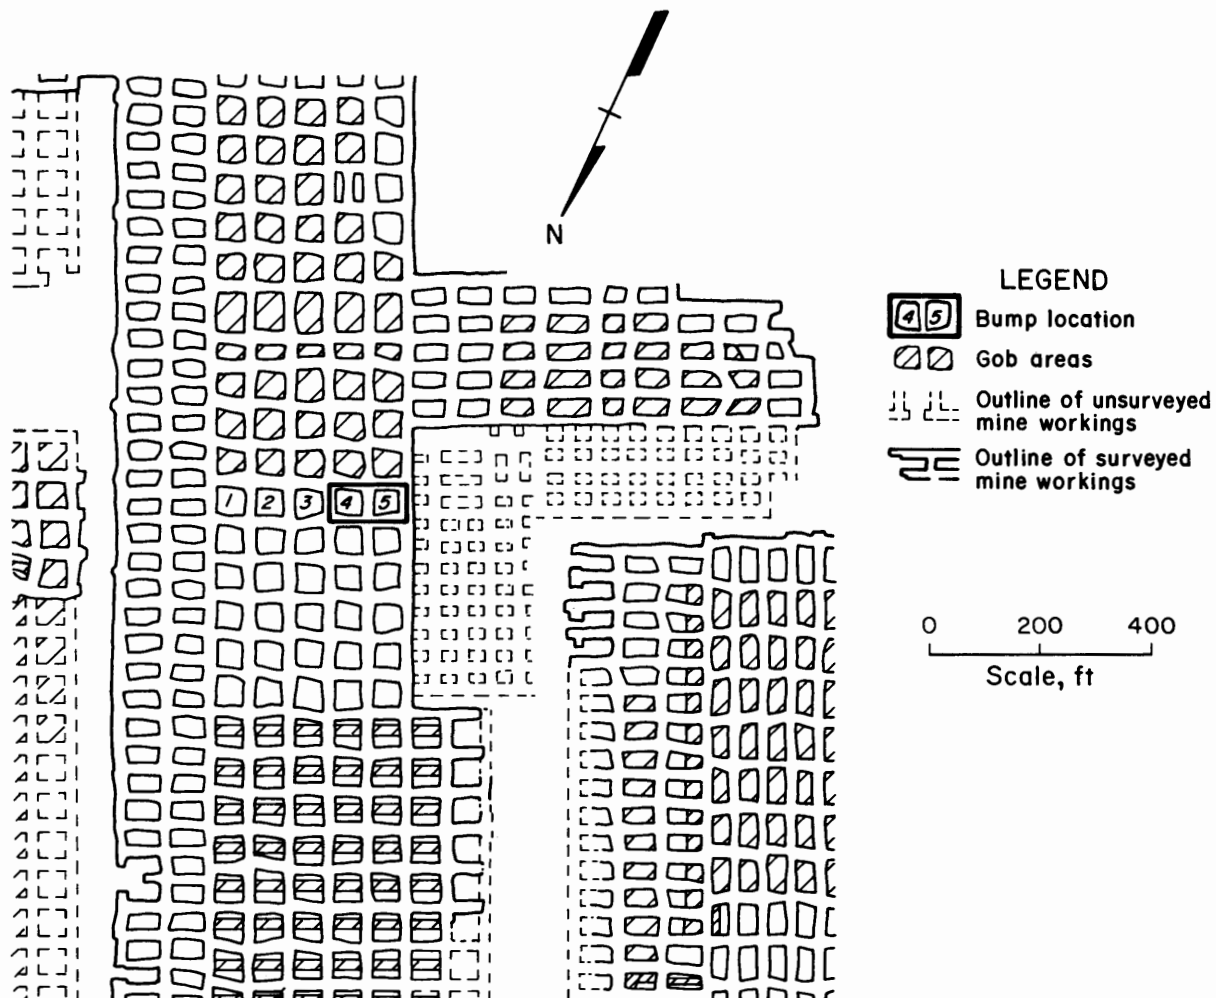
Figure 37.—Overview of bump accident area, mine 4.

On November 29, 1983, a bump occurred, killing one miner and severely injuring another (11). Retreat mining was underway using the twin-mining method. The depth of cover over this area was 752 ft, which approaches the maximum overburden encountered in mine 4. A map of the bump area is contained in figure 37. Pillars numbered 4 and 5 bumped with sufficient force to move a 26.5-st continuous mining machine 15 ft. The machine was cutting the face of pillar 5 when the accident occurred. Mine officials indicated that a similar bump took place 3 weeks prior to the fatality, during the mining of the pillars in by pillars 4 and 5.

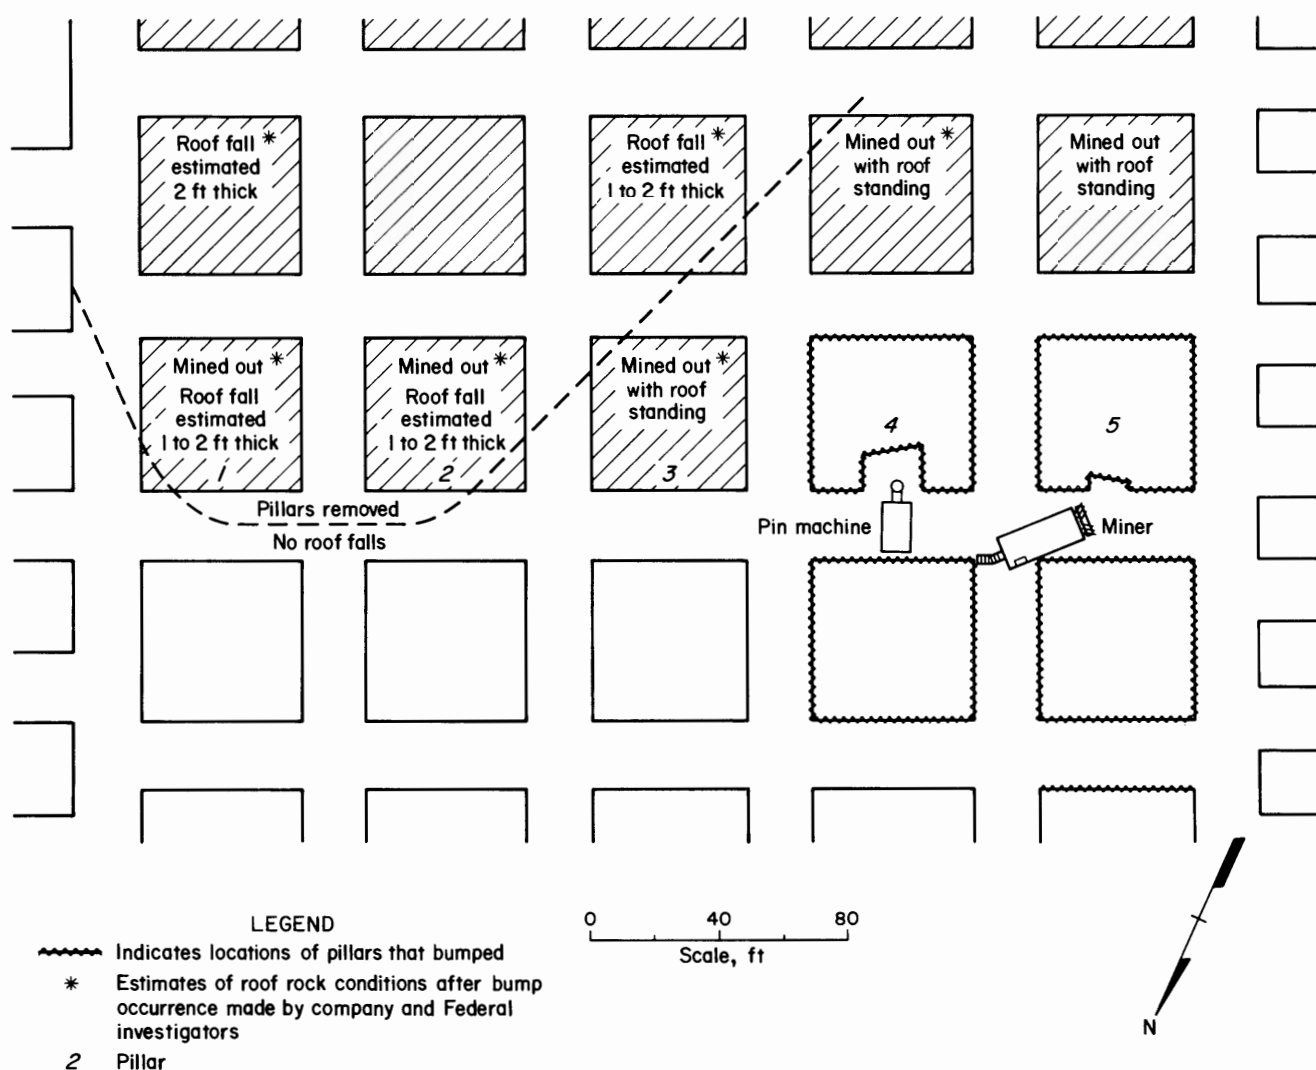
Figure 38.—Plan view of immediate area of bump accident, mine 4.

A closer view of the accident area is mapped in figure 38. Note the standing gob directly inby and to the left of pillar 4, where the pin machine or roof bolter was located. The fall of immediate roof only in the gob area of pillars 1 and 2 also is significant. The combination of the stress transferred from the yield pillars directly adjacent to pillar 5 (fig. 37) by the rigid roof and the standing gob led to the bump event. Five rows of pillars were then left as a barrier (fig. 37), full extraction was discontinued, and a partial extraction procedure was instituted. This pillar splitting reduced the total extraction ratio to less than 60 pct.

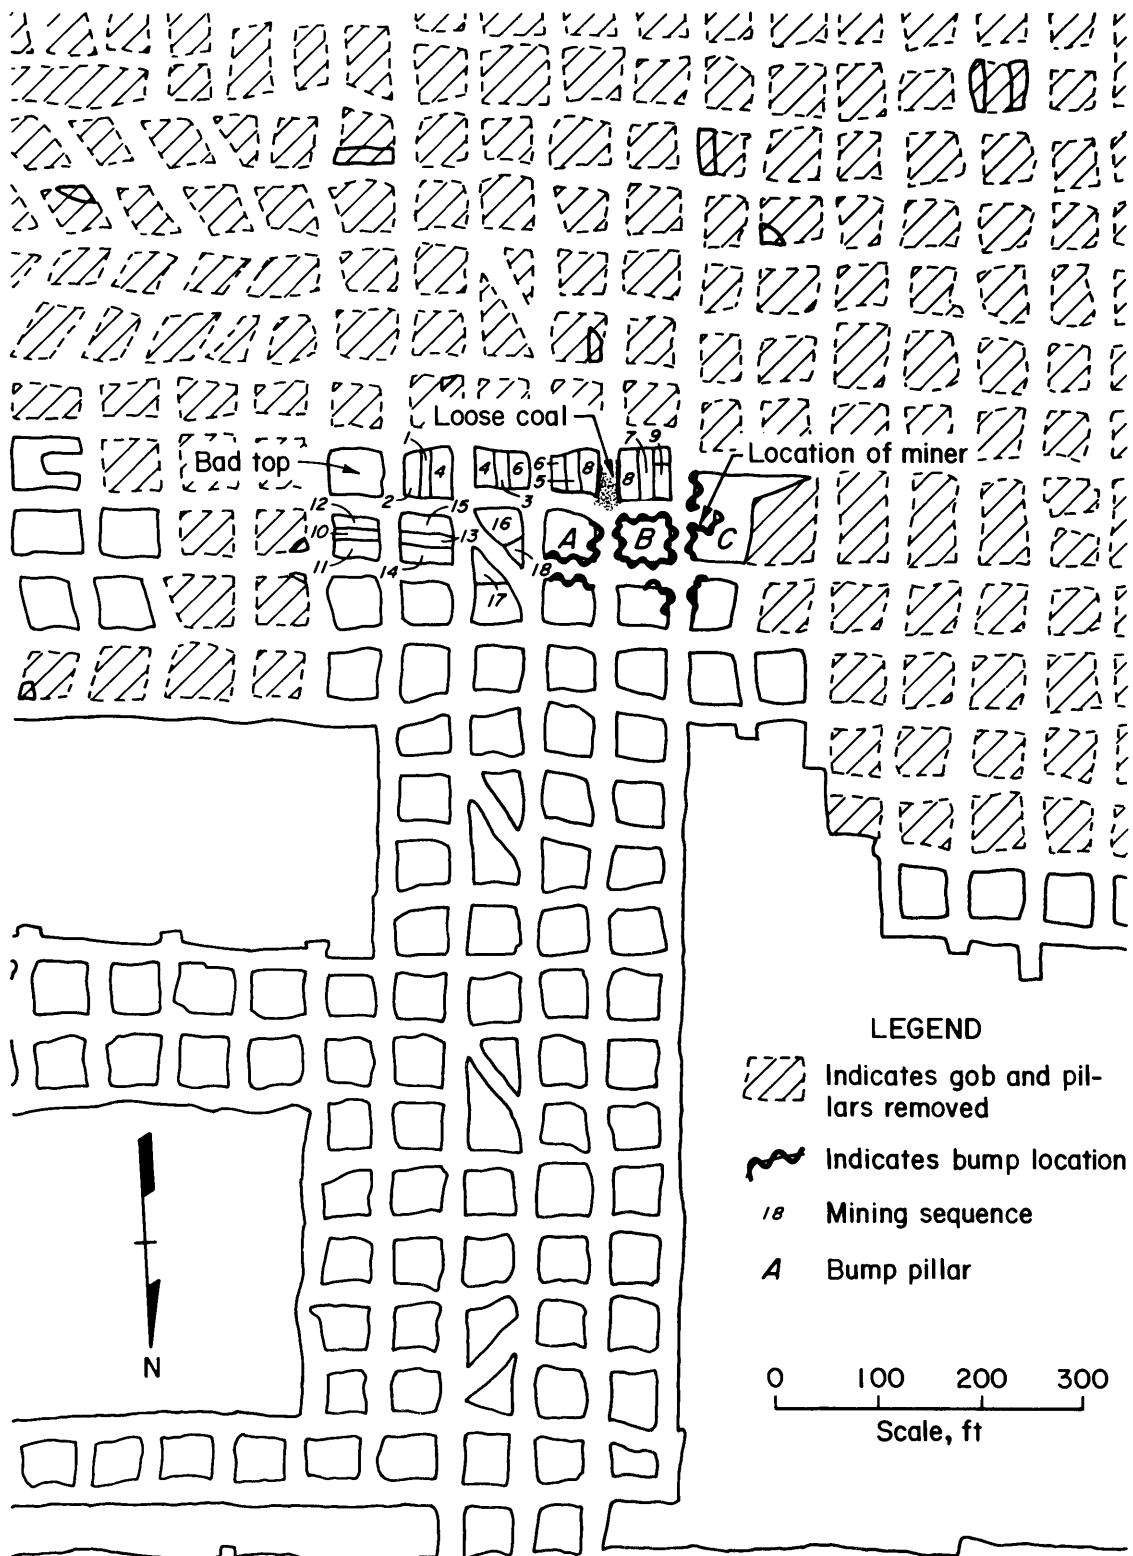
Figure 42.—Plan view of area of bump accident, mine 5.

Sandstone units were present directly subjacent and superjacent to the coalbed in the area of the lost-time-injury bump of February 10, 1984. The Powellton and Eagle Coalbeds were extracted by room-and-pillar retreat methods, 98 and 200 ft, respectively, below the site. It is unknown if multiple seam mining effects contributed to the observed bump phenomenon.

It is theorized that the bump was caused by the extraction of pillars located on a pillar point. A pillar point, as defined by previous researchers (1), is a pillar located at the intersection of at least two gob areas. In this case, the pillars were located between three gob areas (fig. 42). Abutment pressure was transferred from three gobs onto the section. This pressure, combined with unstable roof conditions created by the failure of pillar remnants inby the section, caused the bump.

This event was unique among those studied, for three reasons: (1) The center of the bump was not the pillar containing the working face, (2) a 6- to 12-in separation was formed between the roof and the top of the affected pillars, and (3) roof support timbers were broken into a V-shape, but were loosely held between the roof and bottom. These results seem to indicate that the roof transmitted a hammerlike blow to pillars A, B, and C (fig. 42). This type of failure was defined by previous researchers as a shock bump (1).
